Date 08.01.10	Ref. No. 09TV102R1	Model KDL-32D3000, KDL-32D3010	RASC BC
Subject Vertical Lines [REVISION 1]			IRIS 138A

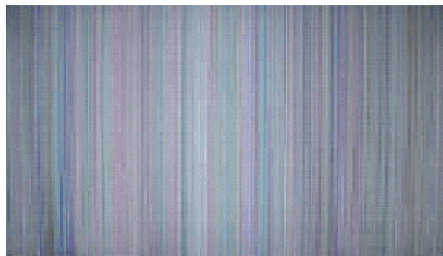
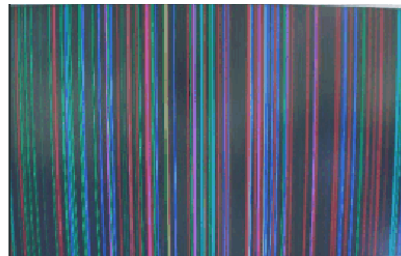
Vertical lines may appear, as in the examples below.

Sulfuration of a chip resistor electrode on the rear side of the T-con board.

Confirm the panel and replace the T-con board, following the guidelines below.
