Date 08.01.10	Ref. No. 09TV102R1	Model KDL-32D3000, KDL-32D3010	RASC BC
Subject Vertical Lines [REVISION 1]			IRIS 138A

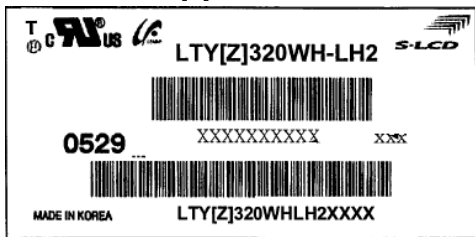
Description	Part number	Label / Remark
LCD Panel	1-802-411-11 1-802-411-12	LTY[Z]320WH-LH2

Confirm the panel and replace the T-con board, following the guidelines below.
